EVALUATION OF THE FUZING SYSTEM FOR THE
MISSILE "LOON" (JB-2)

NAVORD Report 1876

12 August 1952

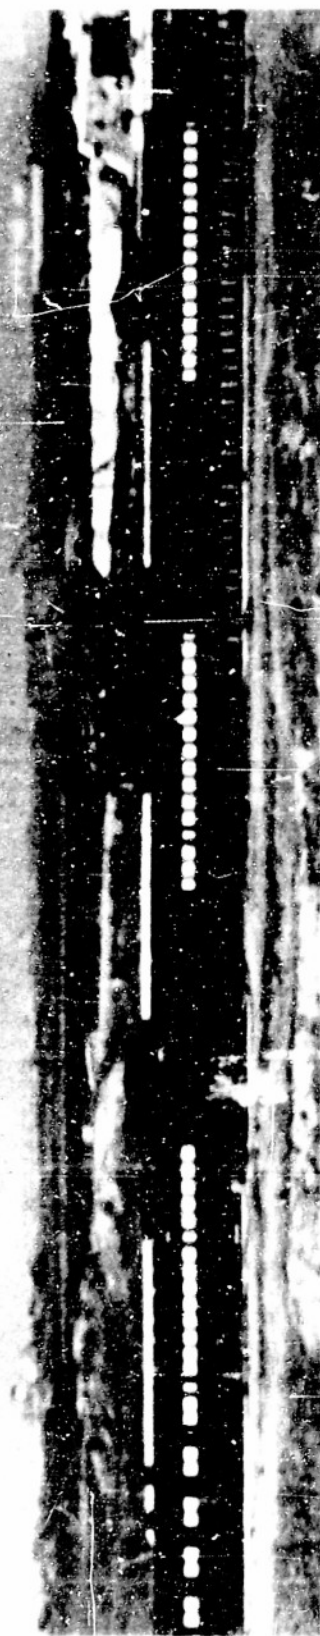
FIG. 1
MISSILE DURING LAUNCHING PHASE

15. The second flight test was conducted on 15 December 1950 from the same launcher. The launching and flight were normal and the test was considered successful in all respects. Figure 1 is a photograph of this missile during the launching phase. Figure 11 shows the telemetered record of the Veeder-Root counter and the two fuzes, in foreshortened form. The information obtained from these curves and its interpretation is as follows:

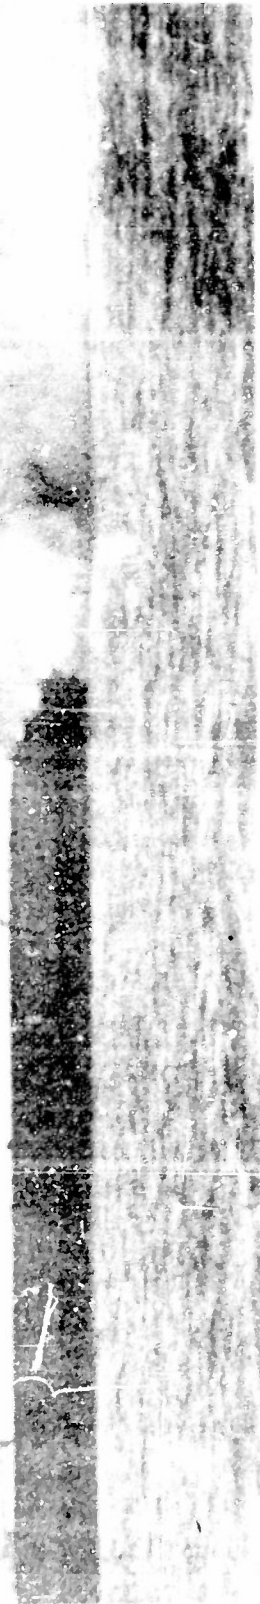
FIG. 2 MISSILE LAUNCHED FROM SURFACED SUBMARINE

16. The third flight test was also conducted on 15 December, after the previously described test indicated proper functioning of all components. The missile, with a service loaded warhead and live fuzes, was launched from a surfaced submarine (see Figure 2) at a position approximately five miles off-shore from the NAMTC launching site. The launching, flight, and terminal dive were all normal as reported by observers. Wing blow-off occurred on command and the missile dove into the sea at a position approximately 46.5 miles from the launching point. At water impact the warhead exploded as expected, creating a water spout of impressive proportions as reported by observers in the chase planes and in a stand-by control plane located nearby at approximately 8,000 ft altitude. All reports indicate that the warhead explosion was of a high order.

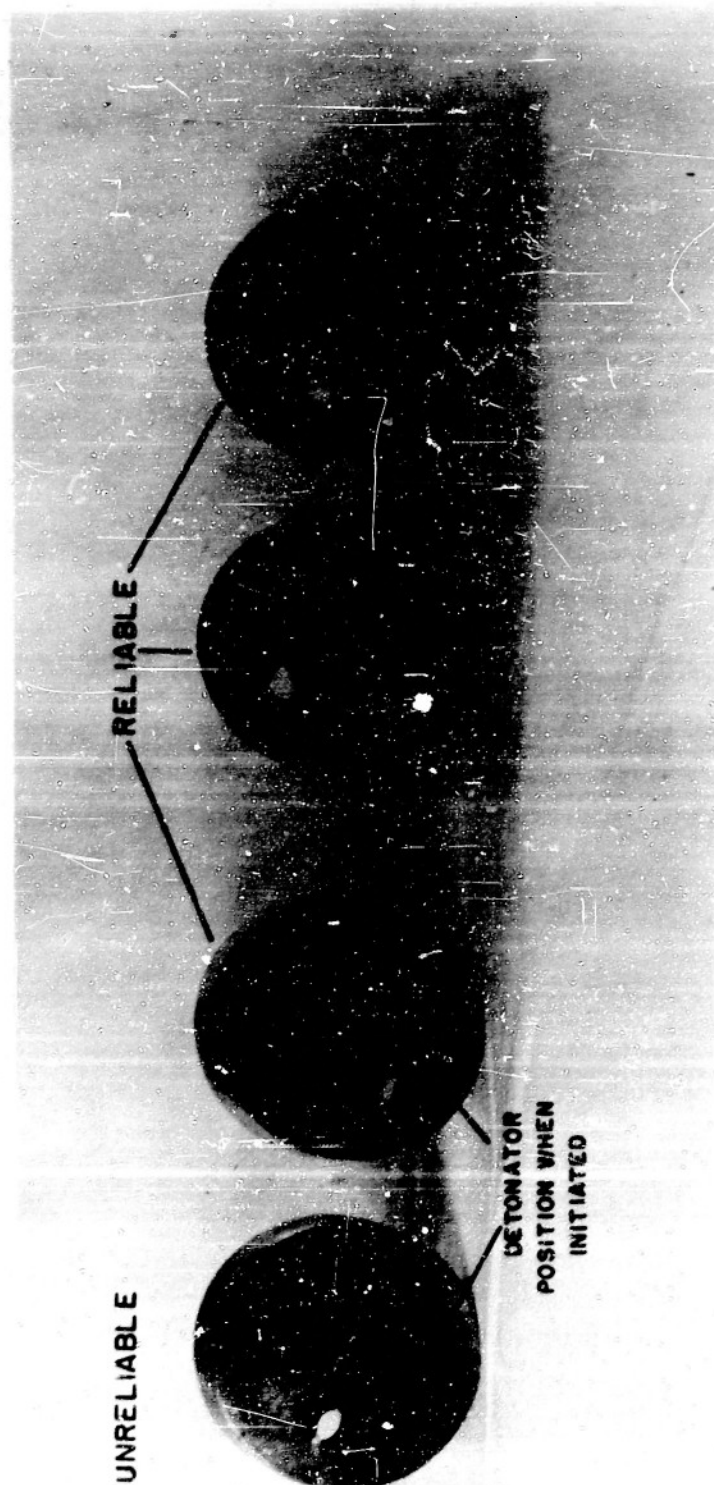
FIG.6 LEAD DISCS FROM SAFETY AND RELIABILITY TESTS

27. In the unarmed condition the detonator located in the rotor is positioned 180° from the tetryl lead located in the lead holder disc. This orientation positions the detonator a distance of .79 inches from the lead. Arming is accomplished when the arming shaft turns the rotor one half turn. The detonator blast hole is then in line with the tetryl lead. A measure of the safety and reliability of the fuze was made by conducting a Bruceton sequential test. An unsafe condition was believed to exist when the tetryl lead cup was compressed diametrically and pushed into the booster as shown in figure 7. In the normal condition the lead cup is approximately level with the lead disc. The reliability tests were in most cases conducted with live boosters, however a few were conducted with inert boosters. Figure 5 shows the effect on a booster of firing a detonator in an unreliable position. Lead discs from these tests are shown in figures 6 and 7. The Bruceton tests were run by using the shortest distance between the detonator and the tetryl lead as the variable tested; however, the results are presented as angular measurements for convenience. The 50% reliable and the 50% unsafe positions were determined from the Bruceton sequential test. The 50% reliable position is defined as the position where 50% of the tests will be expected to result in a high order detonation of the booster. The 50% unsafe position is defined as the position where 50% of the tests will be expected to result in the unsafe condition defined above. These tests indicate that the fuzes are expected to be 50% reliable when the distance between the detonator center and the lead center is 0.19 inches or at an angle of 28° from armed, with a standard deviation of .03 inches. The 50% unsafe position was found to be at a distance of 0.31 inches or 47° from the armed position, with a standard deviation of .01 inches. From this information the 99.9% reliability point was found to be 0.10 inches or 14° from completely armed, and the 0.1% unsafe position was determined as 0.34 inches or 51° from armed. The curves of figure 12, which were determined by a statistical analysis of the Bruceton test, indicate a measure of the reliability and unsafety of the fuze. It is obvious that the 99.9% reliability position and the 0.1% unsafe position cannot be accurately predicted since the sample size is small;
